Dakhleh Oasis Project
Columbia University
Excavations at Amheida 2007
Architectural Conservation Works

AMHEIDA PYRAMID
2007 SEASON

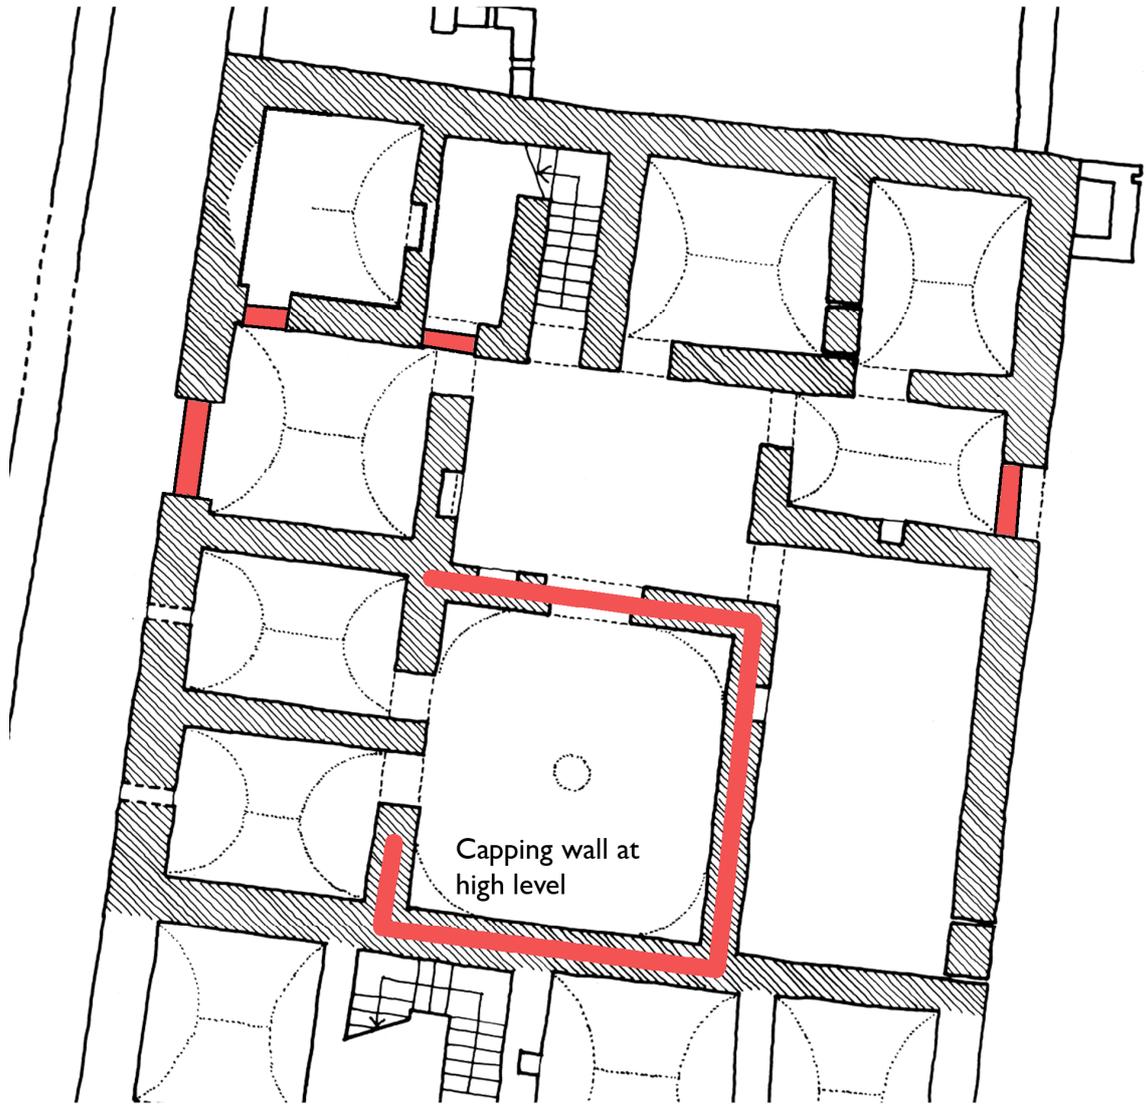
Figure 1

The house was completely excavated this season, and no further in situ conservation work either of the wall paintings or the structure of the building is anticipated. With this in mind, and following on from the interventions last season, a number of new blocking walls were built to allow for internal areas of the villa to be backfilled independently from each other. These walls are shown on the attached plan, Fig.1. New brickwork was used in the capping of the existing walls around the painted main room of the house. This followed the original brick dimensions of 8 x 17 x 34cm but without the inclusion of straw/*tibn* (to avoid termite infestation). The mortar used was a mud mortar made from a combination of imported clay (*tafl*), old crushed fragmentary bricks, and a small percentage of fly-ash (*osromil*).

Amheida Roman Villa: location of mudbrick walls constructed 2007 season

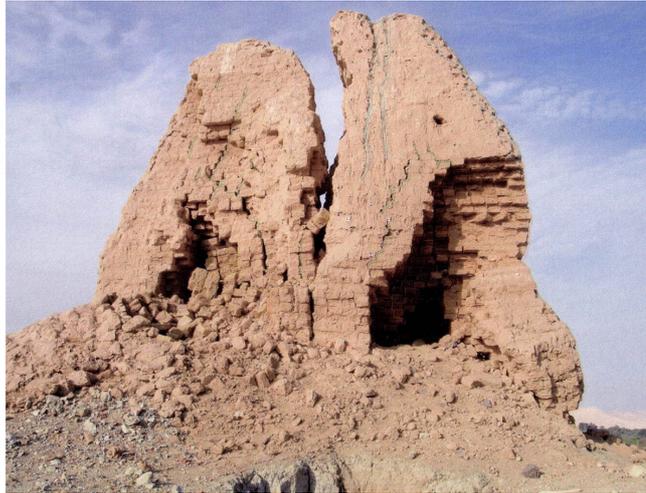
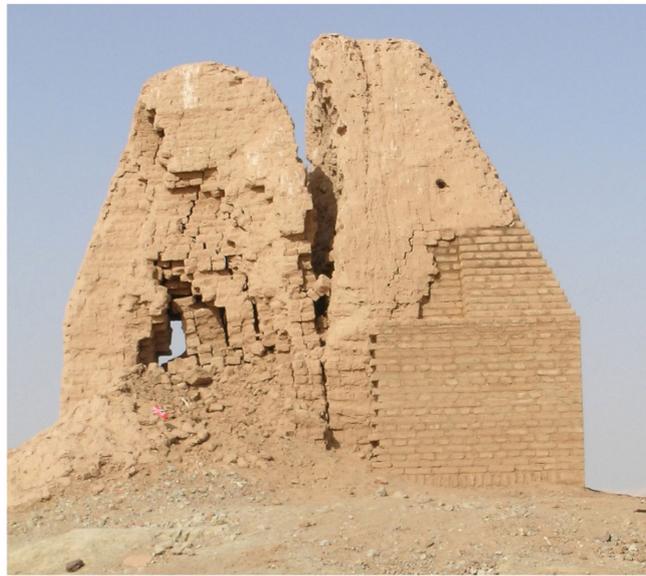
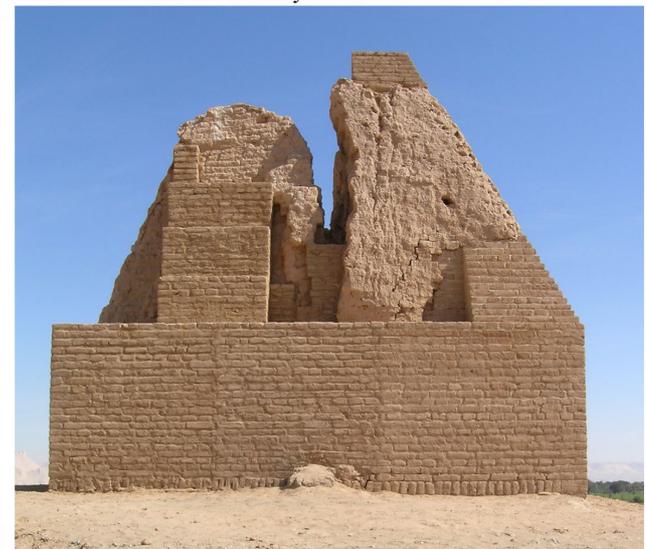
Figure 4

South face of Amheida Pyramid pre-consolidation

Post-consolidation February 2006

SOUTH FACE POST CONSOLIDATION MARCH 2007

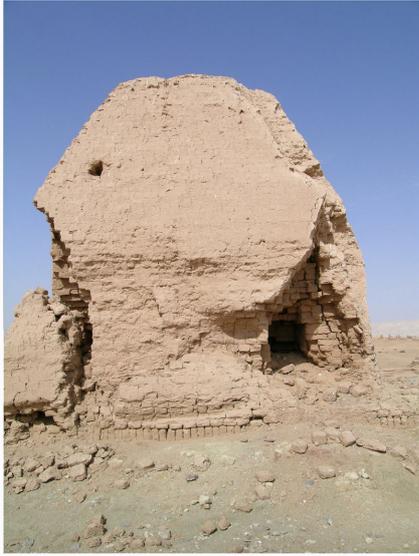
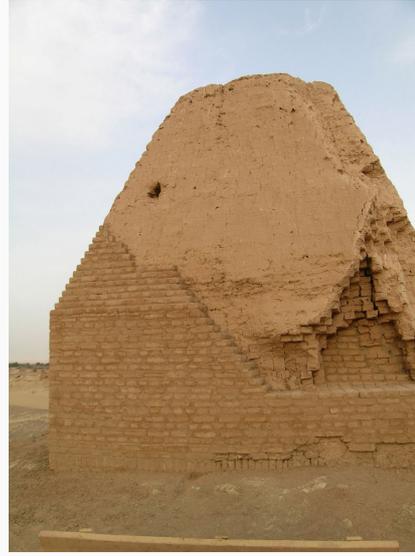
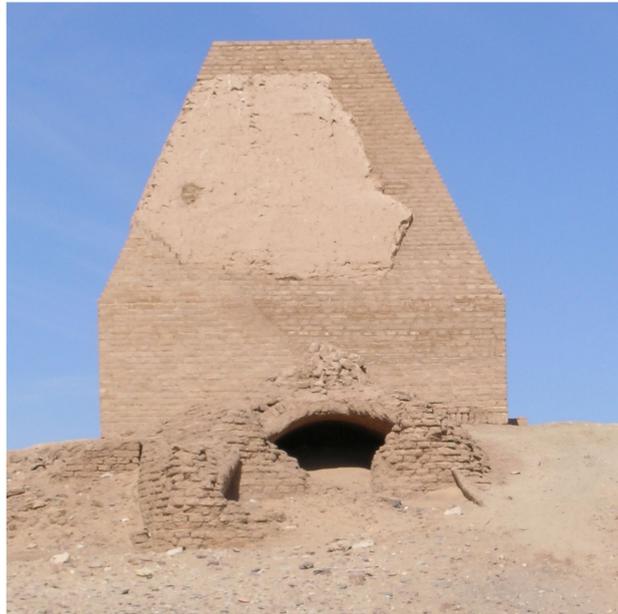
Figure 5

East face before consolidation

East face after consolidation

EAST FACE POST CONSOLIDATION MARCH 2007

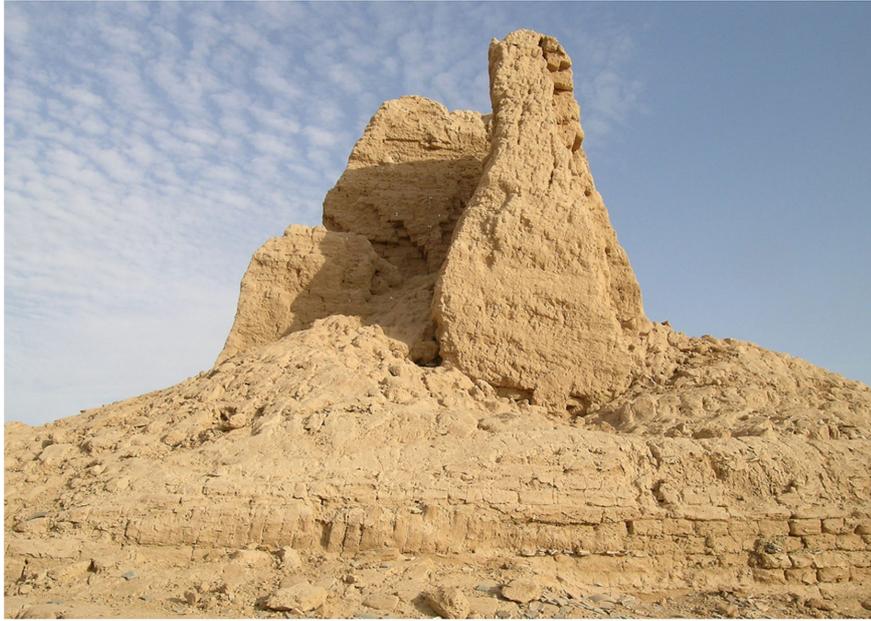
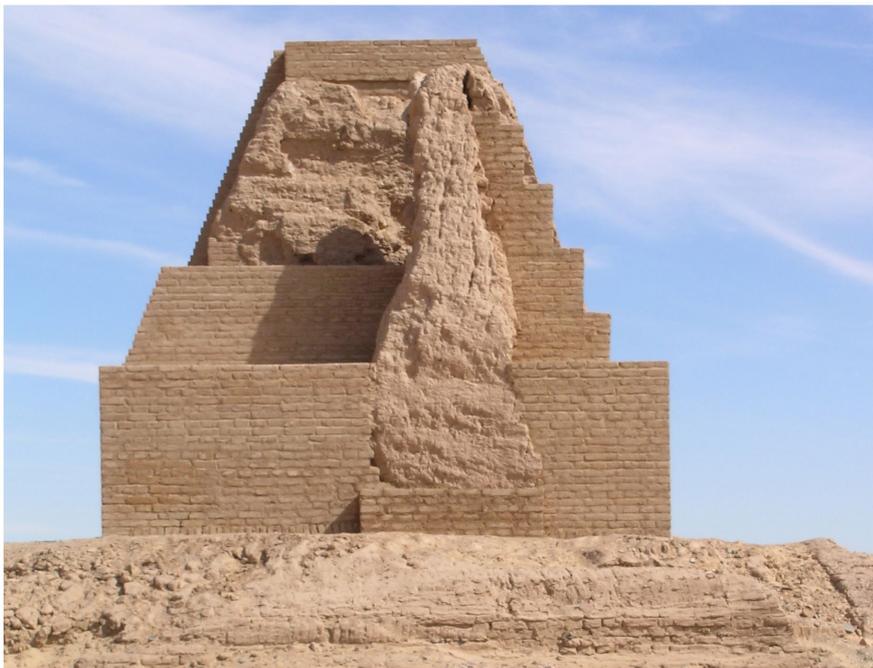
Figure 6

Work was concentrated on consolidating the north-west and south-west corners of the pyramid, which had been seriously damaged by the loss of bonded masonry, either as a result of the structural failure of the western half of the pyramid due to subsidence, or due to anthropogenic damage. New bricks, matching the dimensions of the original Roman bricks but without the inclusion of straw (to avoid termite infestation), have been used in the consolidation (8 x 17 x 35cm after cleaning and squaring up). The existing bonding pattern (English Bond of alternating stretchers and headers) was also replicated in the new brickwork. The mortar used in the consolidation works was a mud mortar made from a combination of imported clay (*tafl*), old crushed fragmentary bricks from the collapse of the pyramid, and a small percentage of fly-ash (*osromil*).

WEST FACE OF PYRAMID BEFORE (TOP) AND AFTER CONSOLIDATION

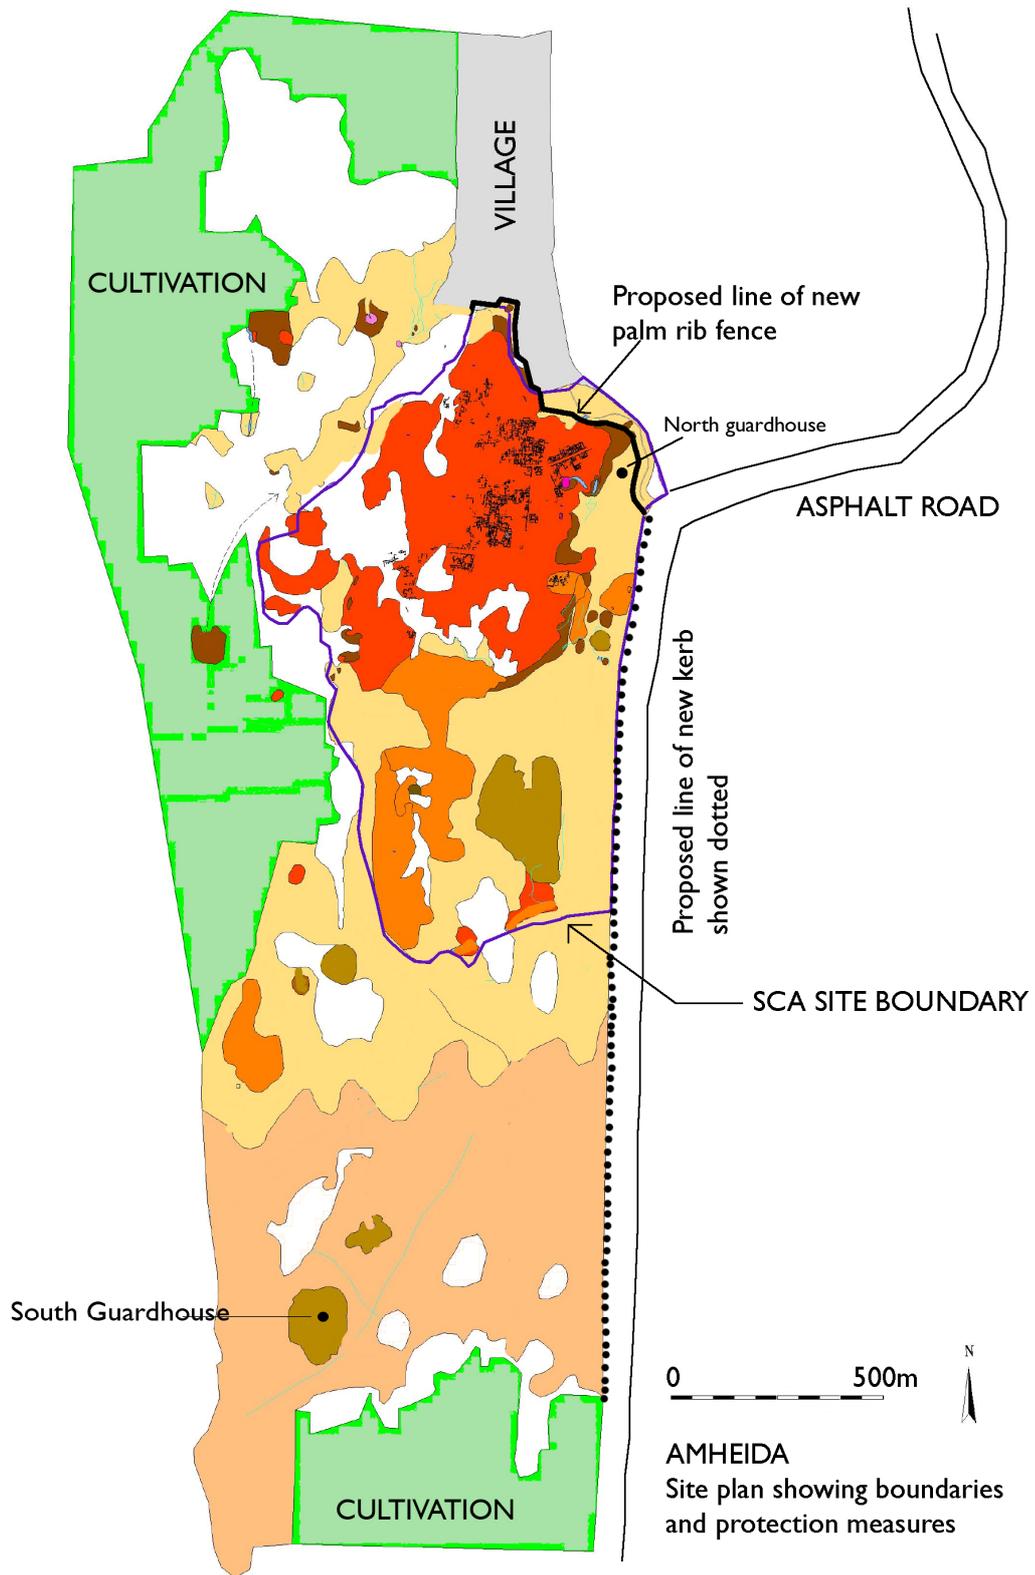
Figure 7

The archaeological area of Amheida extends considerably to the south of the land currently in the control of the SCA, according to information received from the local Inspectorate (see Fig.7 below). Cemetery areas and the southern (red) pyramid are, for example, outside this zone. This would indicate that the first site protection measures should be bureaucratic rather than physical. The fact that the boundaries of the archaeological resource and the area currently designated as a site do not correspond must be addressed by the SCA, perhaps through the EAIS before the latter body is phased out. This mismatch between a protected area and the real extent of a given site is normal situation, but the issue should be raised before any physical action is taken. The local Inspectorate has, indeed, acknowledged the real extent of the site by locating a new guardhouse to the south, outside the boundary it technically controls (see below).

The site cannot be easily protected from individuals on foot, or from animals. The main threat to the site, however, comes from vehicles (4 x 4 cars, loaders, or tractors) which are capable of doing a considerable amount of damage whether intentionally or unintentionally. A new guard house in the southern part of the site (presently unoccupied) will one day provide protection additional to that already offered by the existing guardhouse on the north-east edge of the site (an area which has a good view of the road but almost no view of the most vulnerable areas of the site).

Neither of the guard houses, however, will prevent vehicles from continuing to access the site, so it is therefore proposed to create a physical barrier between the road and the site. Of the three options available (a fence, a ditch, or a kerb to the edge of the road), the installation of a concrete kerb beside the road is recommended for the following reasons: it is more durable than a palm rib fence, needs little to no maintenance, is cheaper than a steel fence, and does not risk undermining the road itself in any way. The kerb will not appreciably affect the perception of the site from the road itself, unlike a fence.
