Dakhleh Oasis Project
Columbia University
Excavations at Amheida 2007
Architectural Conservation Works

AMHEIDA PYRAMID
2007 SEASON

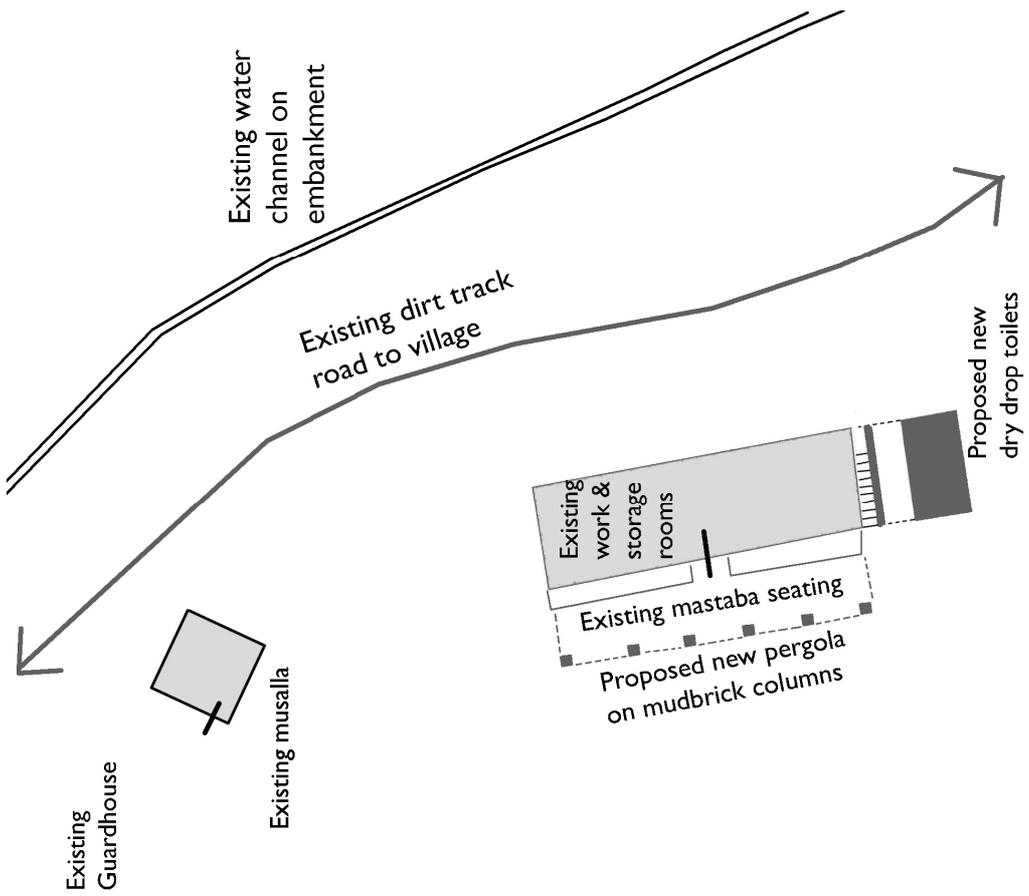
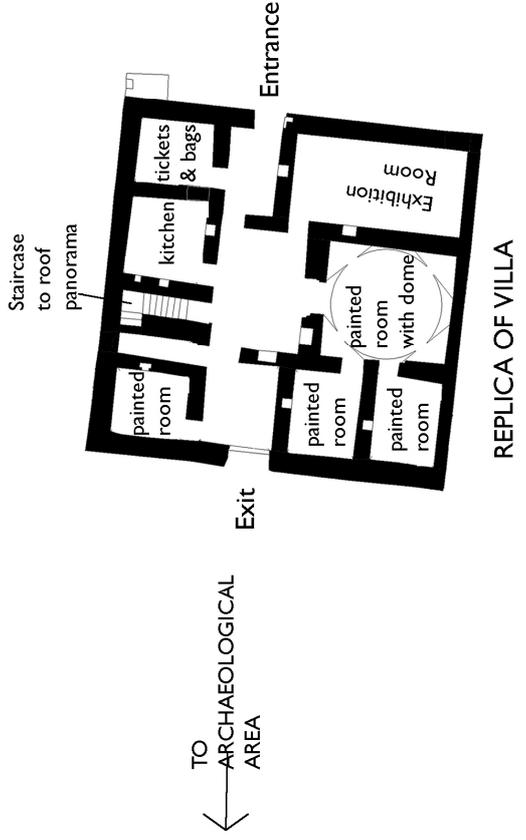
Figure 1

AMHEIDA ROMAN VILLA
 Proposed location plan of
 villa replica and associated
 structures March 2007

It was agreed that a project to build a replica of the Roman House, suitable for visitors to access, would be initiated and put forward to the SCA Permanent Committee for their approval, following the approval given on site by the Director of the SCA Dakhleh office, Maher Bishendi. The replica, constructed of mud brick, would be located at the lowest level of the site near existing work and guard houses, away from any areas of archaeological interest. Additional features, such as dry-drop toilets and a shaded pergola area for seating should also be provided at the same time.
